Spring 2012 CCTV Video Inspection of selected sanitary sewer lines

**Clarke St., Narragansett Ave., Wollcott St.,
Hamilton Ave., Cananicus Ave. & Bay View Drive.**

Infrastructure Technologies Data Generated CCTV Video Inspection Report (PACP Certified)

**Town of Jamestown, WWTP
93 Narragansett Avenue Jamestown, RI 02835**

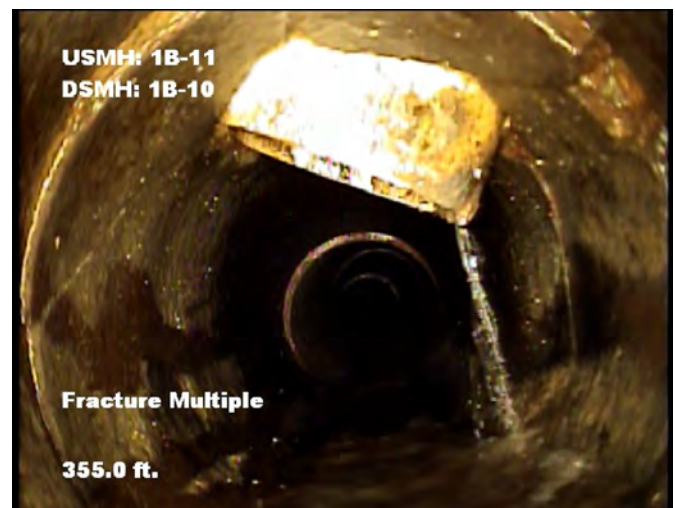
Distance: 355.0 ft. Grade: 4
Condition: Fracture Multiple
Remarks: N/A

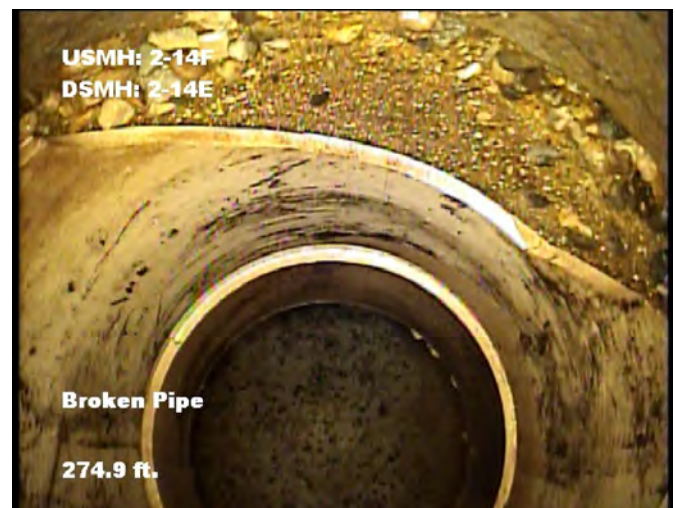
Distance: 274.9 ft. Grade: 3
Condition: Broken Pipe
Remarks: N/A

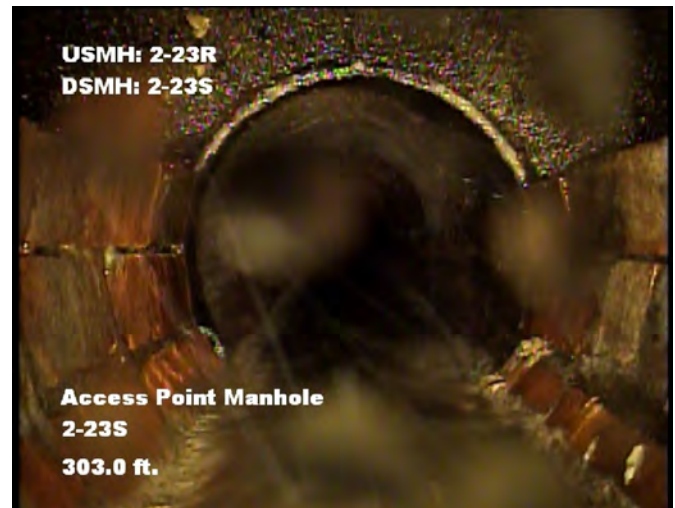
Distance: 302.1 ft. Grade: 5
Condition: Infiltration Gusher
Remarks: In the manhole

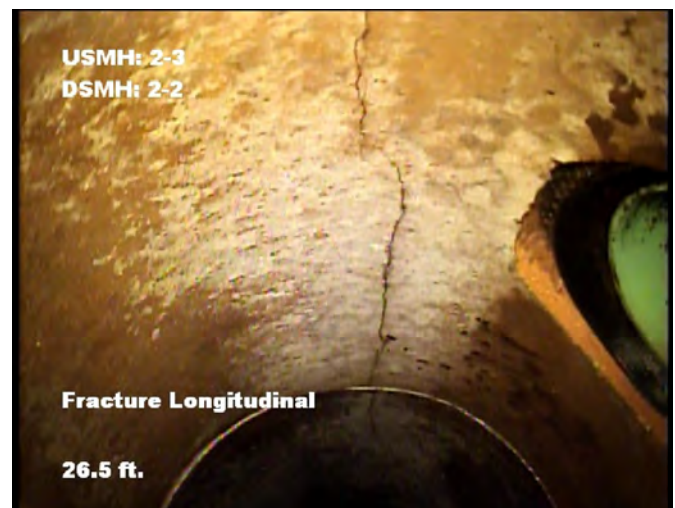
Distance: 26.5 ft. Grade: 3
Condition: Fracture Longitudinal
Remarks: N/A

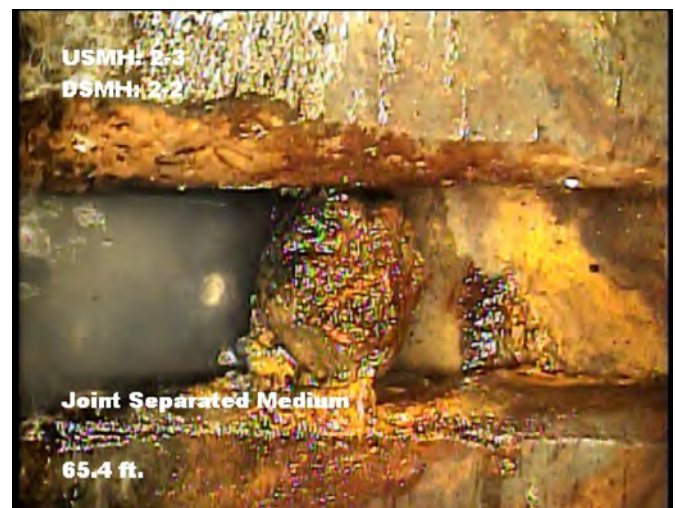
Distance: 65.4 ft. Grade: 1
Condition: Joint Separated Medium
Remarks: N/A

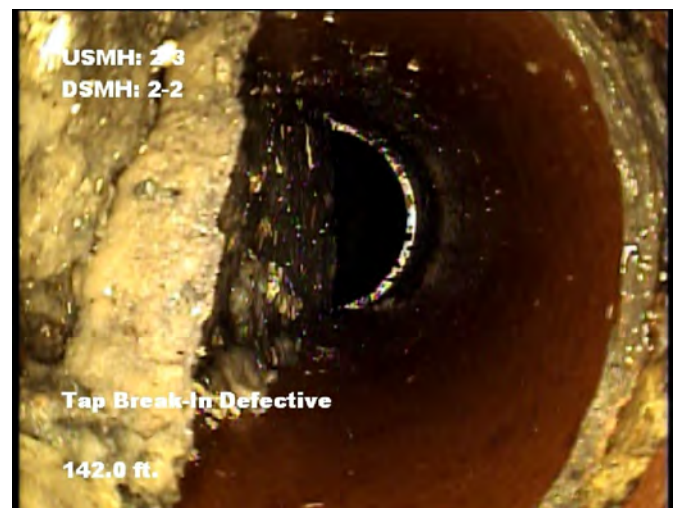
Distance: 142.0 ft. Grade: 3
Condition: Tap Break-In Defective
Remarks: N/A

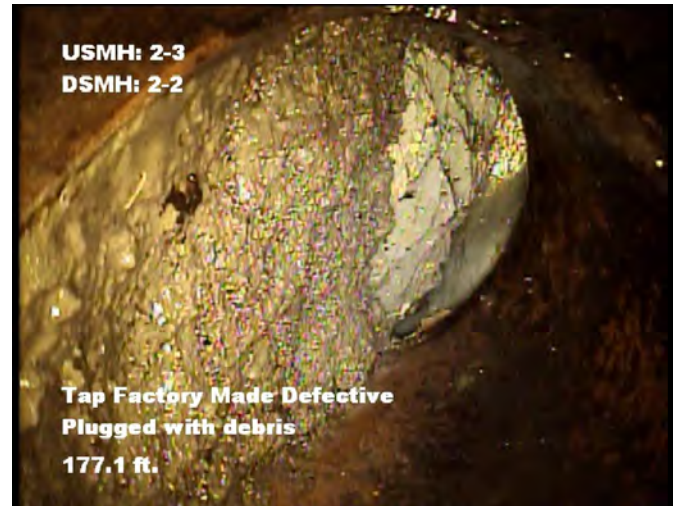
Distance: 177.1 ft. Grade: 2
Condition: Tap Factory Made Defective
Remarks: Plugged with debris

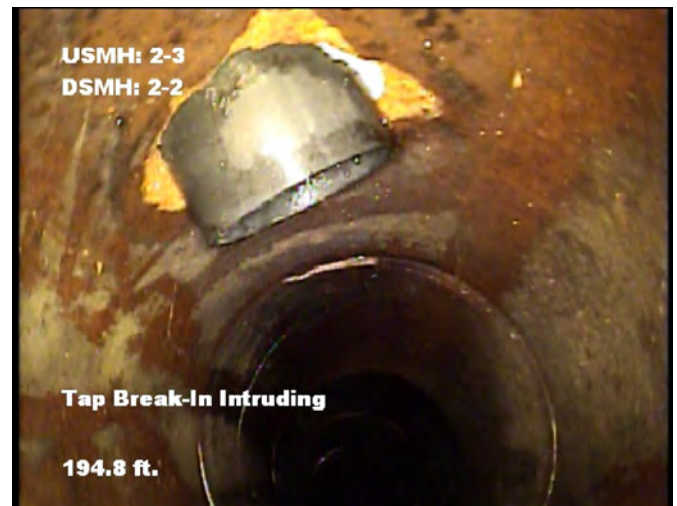
Distance: 194.8 ft. Grade: 2
Condition: Tap Break-In Intruding
Remarks: N/A

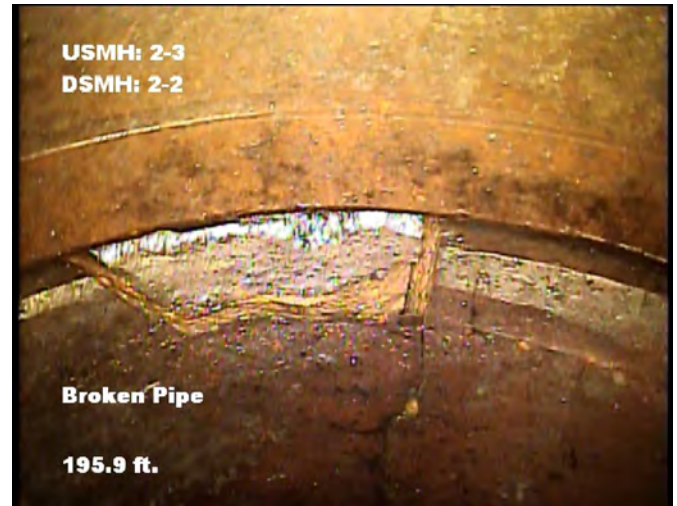
Distance: 195.9 ft. Grade: 3
Condition: Broken Pipe
Remarks: N/A

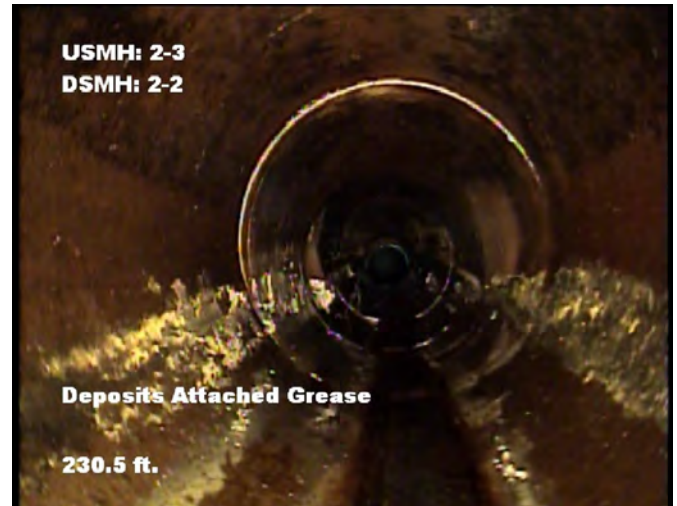
Distance: 230.5 ft. Grade: 2
Condition: Deposits Attached Grease
Remarks: N/A

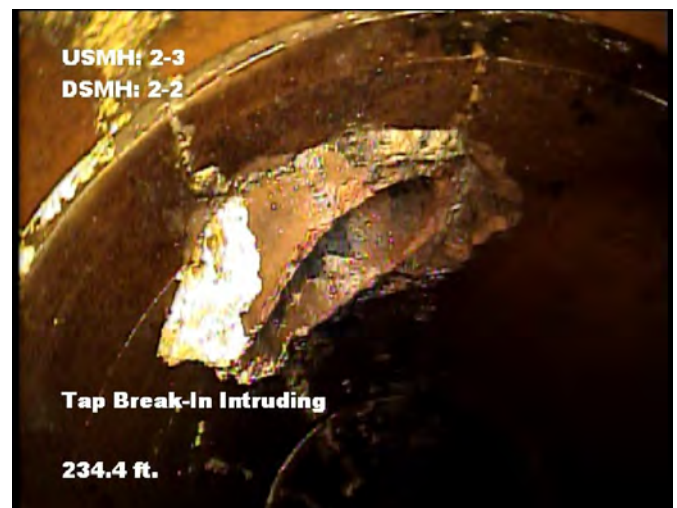
Distance: 234.4 ft. Grade: 2
Condition: Tap Break-In Intruding
Remarks: N/A

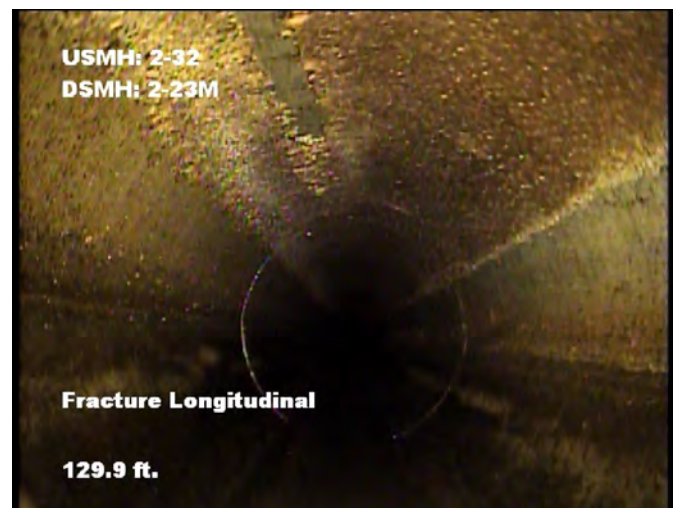
Distance: 129.9 ft. Grade: 3
Condition: Fracture Longitudinal
Remarks: N/A

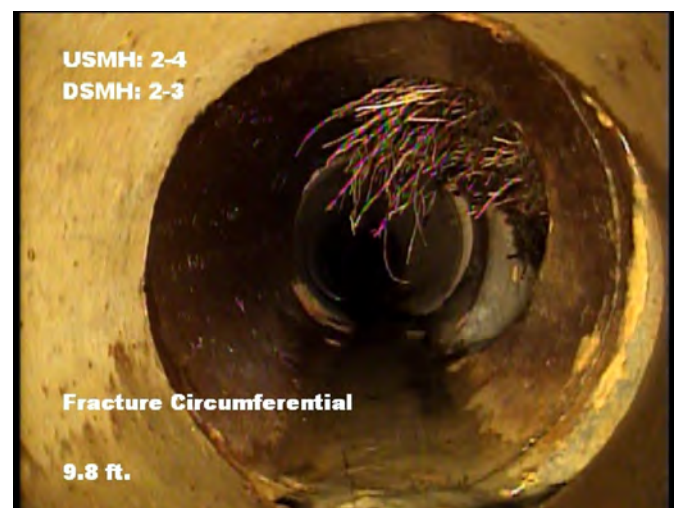
Distance: 9.8 ft. Grade: 2
Condition: Fracture Circumferential
Remarks: N/A

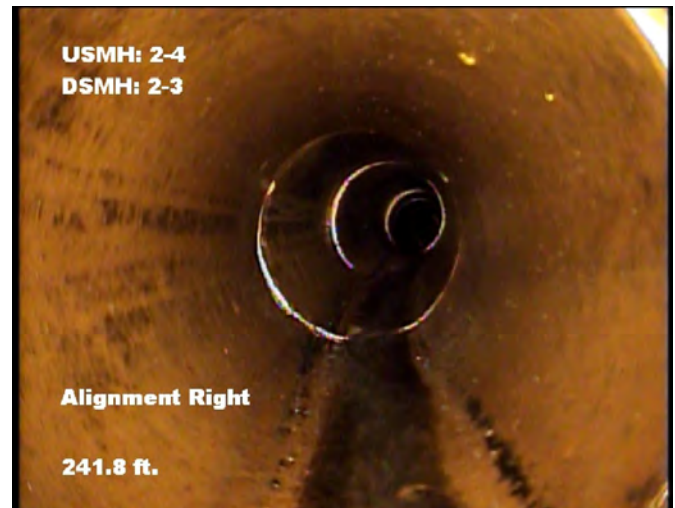
Distance: 241.8 ft. Grade: 2
Condition: Alignment Right
Remarks: N/A
